## Site Inspection Report Summary

**Property Address:** 6231 PA-88 Finleyville, PA 15332

**Inspection Date:** 06/10/2020

## **Photo Report of Koteles Garage**

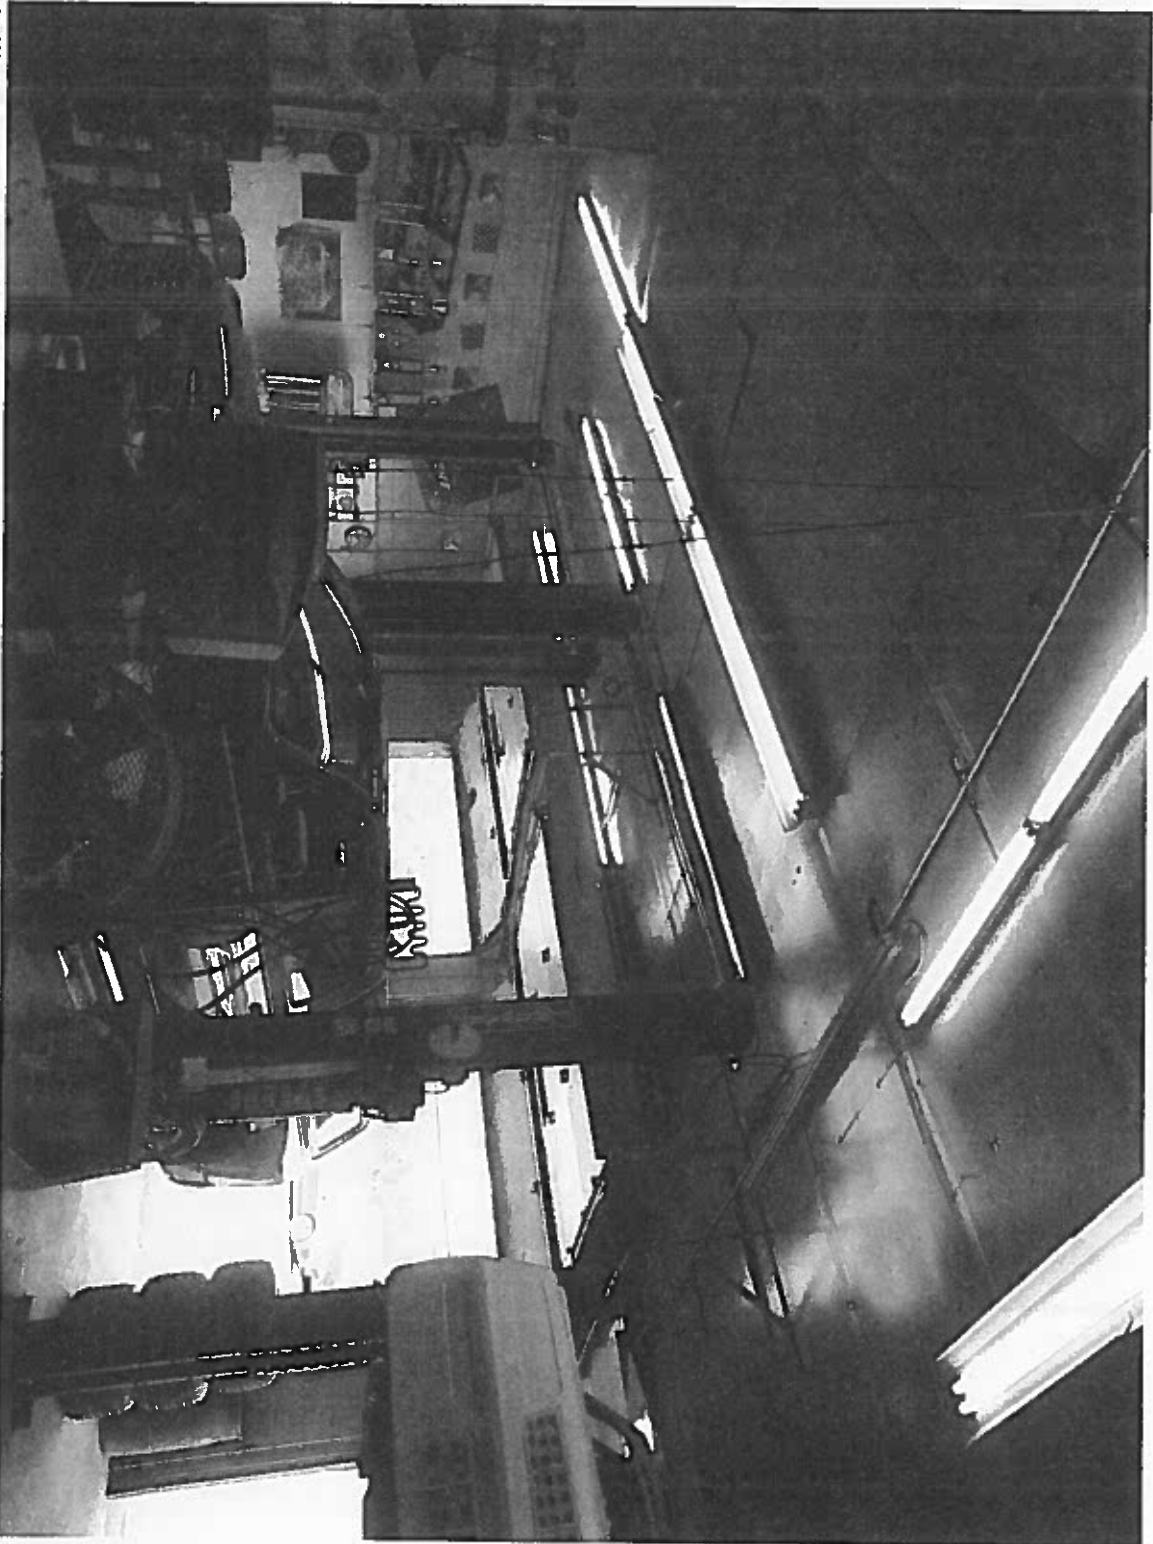
Ceiling damage in main bay area.

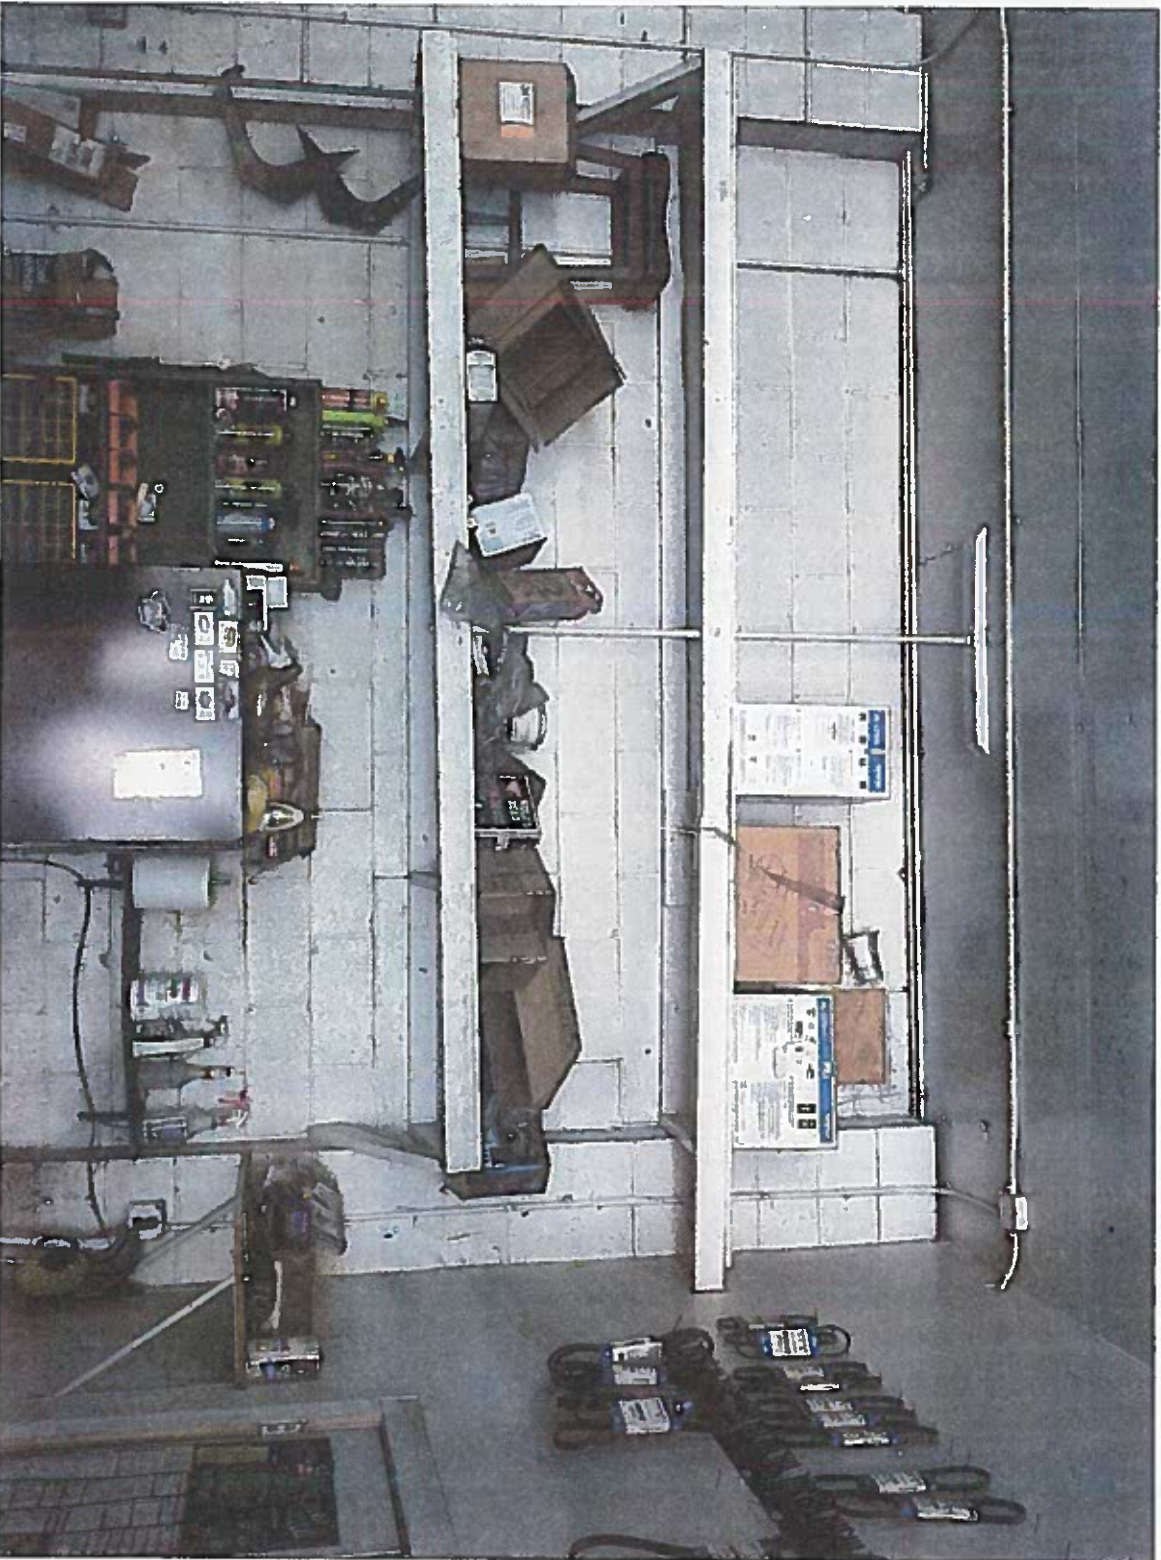
Crooked shelving. Previously overloaded?

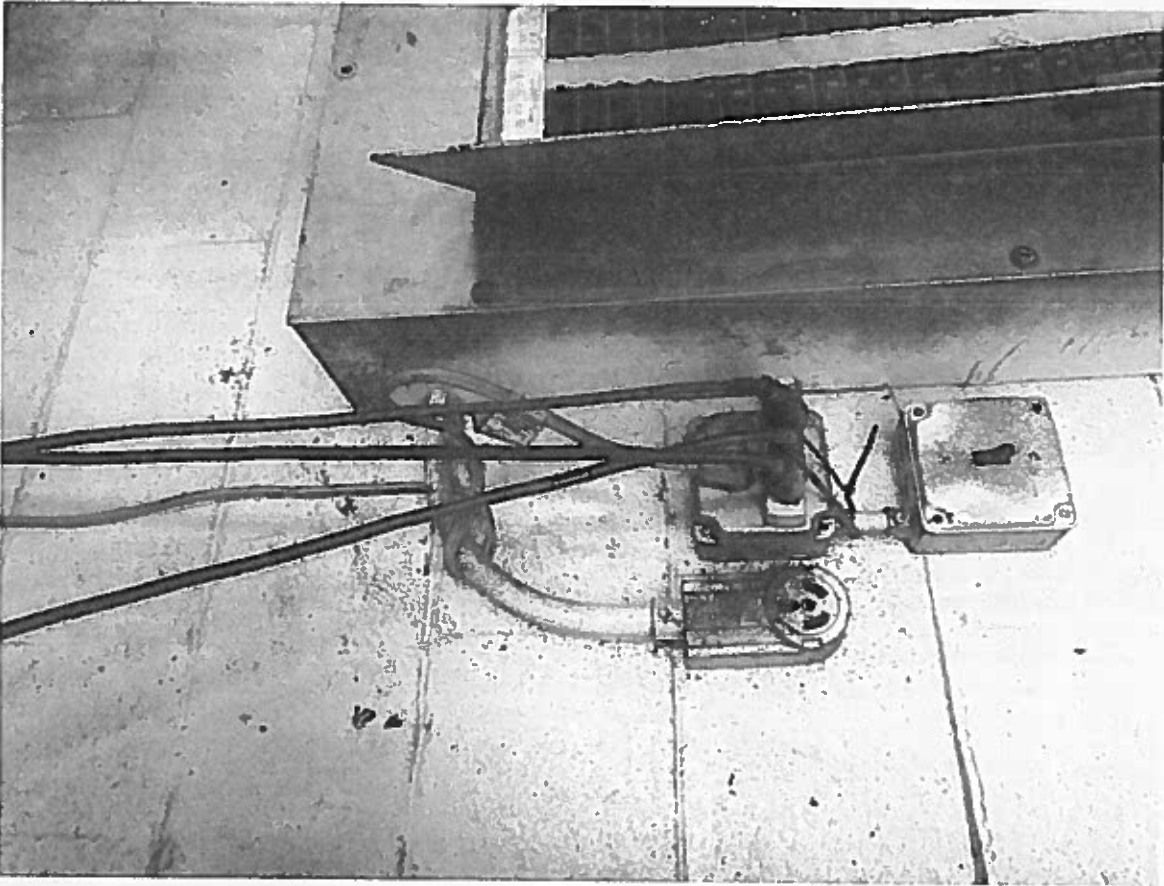
In the front service bay area, one area had a large amount of equipment plugged into one electrical circuit.

Highly loaded single circuit.

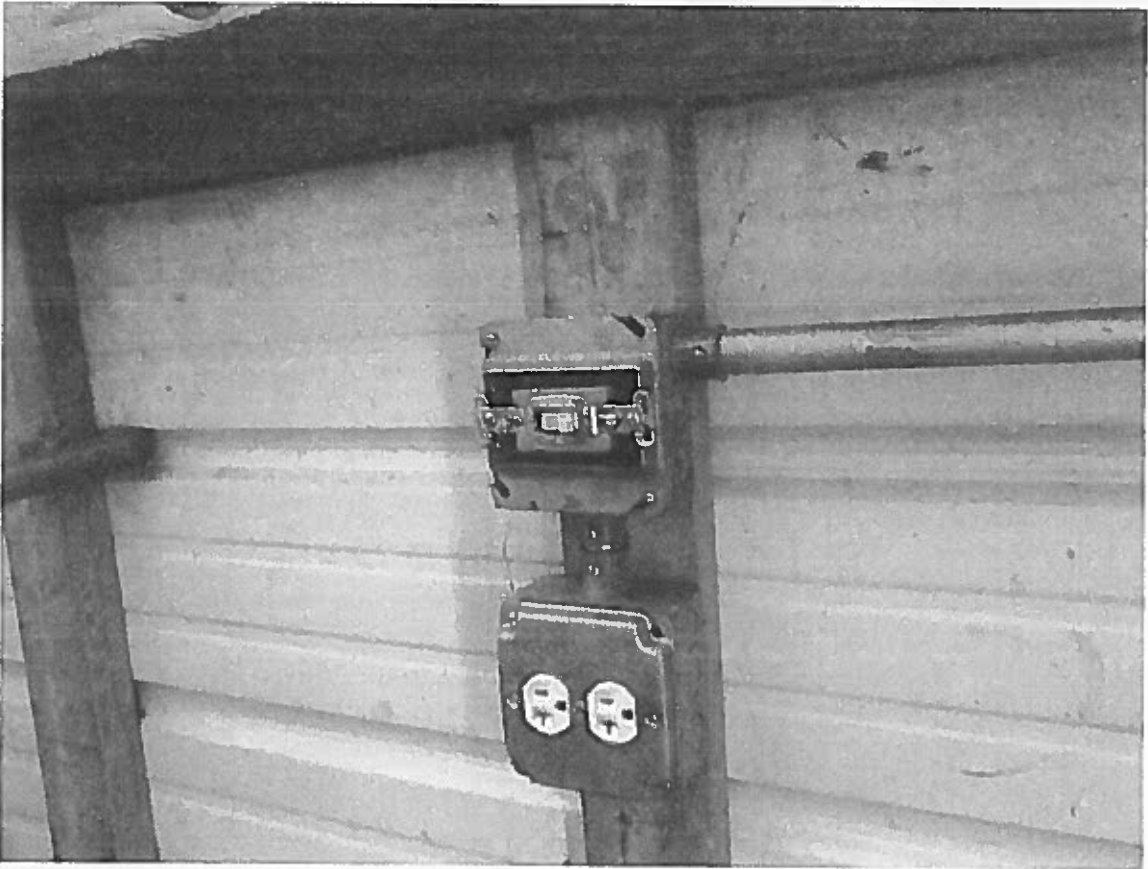
In the white building at the rear of the property, the light switch closest to the access door to the building was missing a light switch cover.

Missing light switch cover in rear white building.

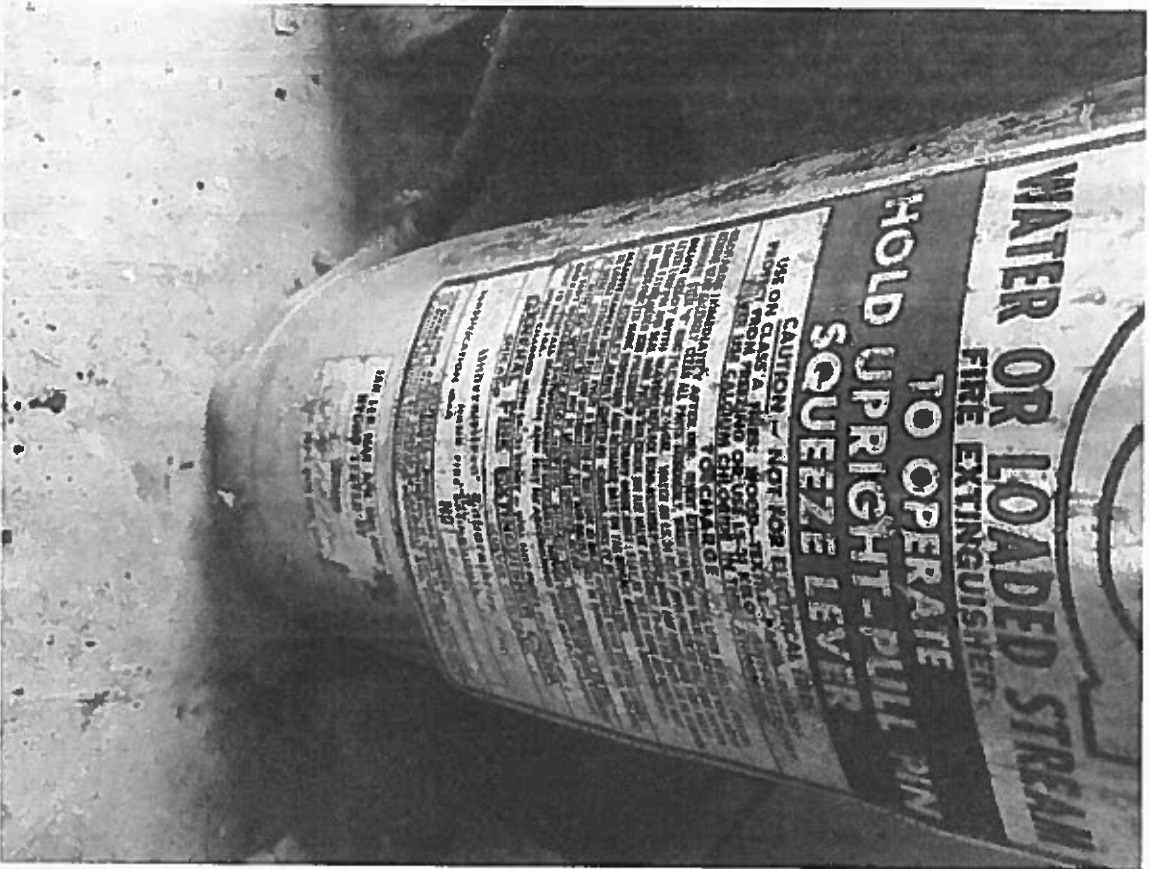
Old partially charged fire extinguisher. Only fire suppression found in rear building.

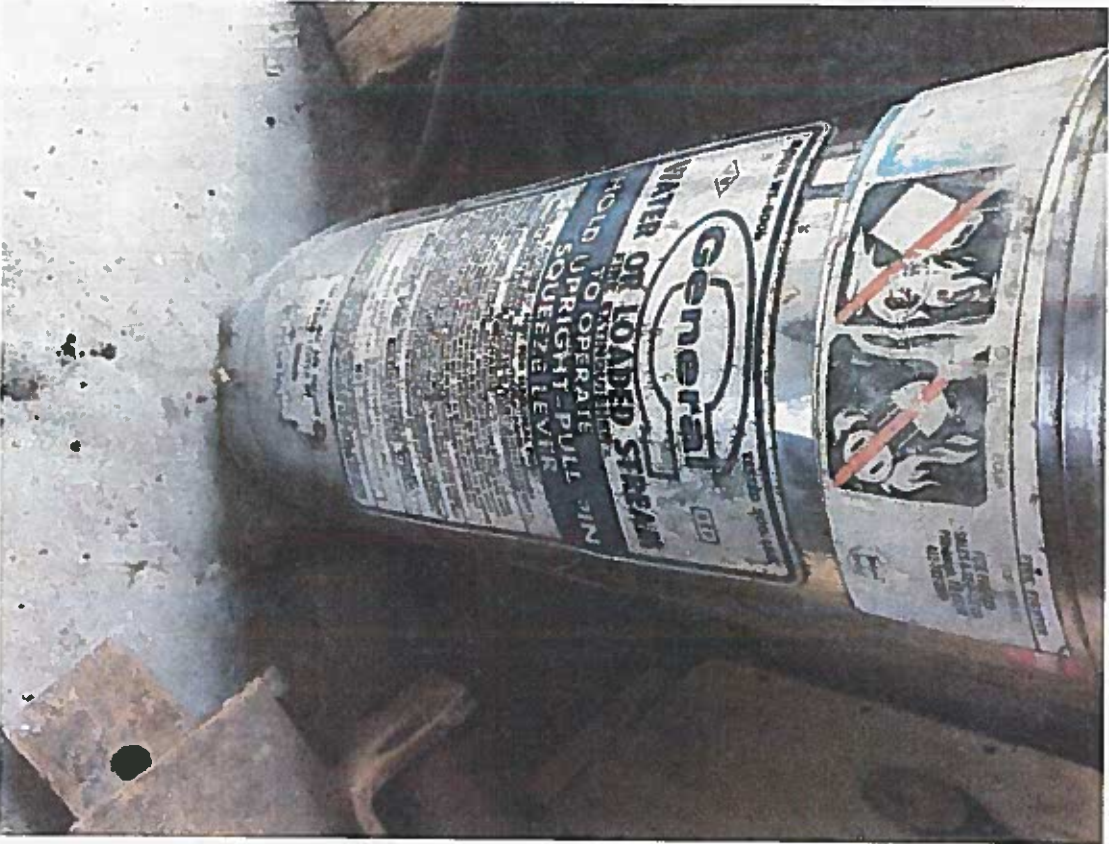
Old partially charged fire extinguisher. Only fire suppression found in rear building.

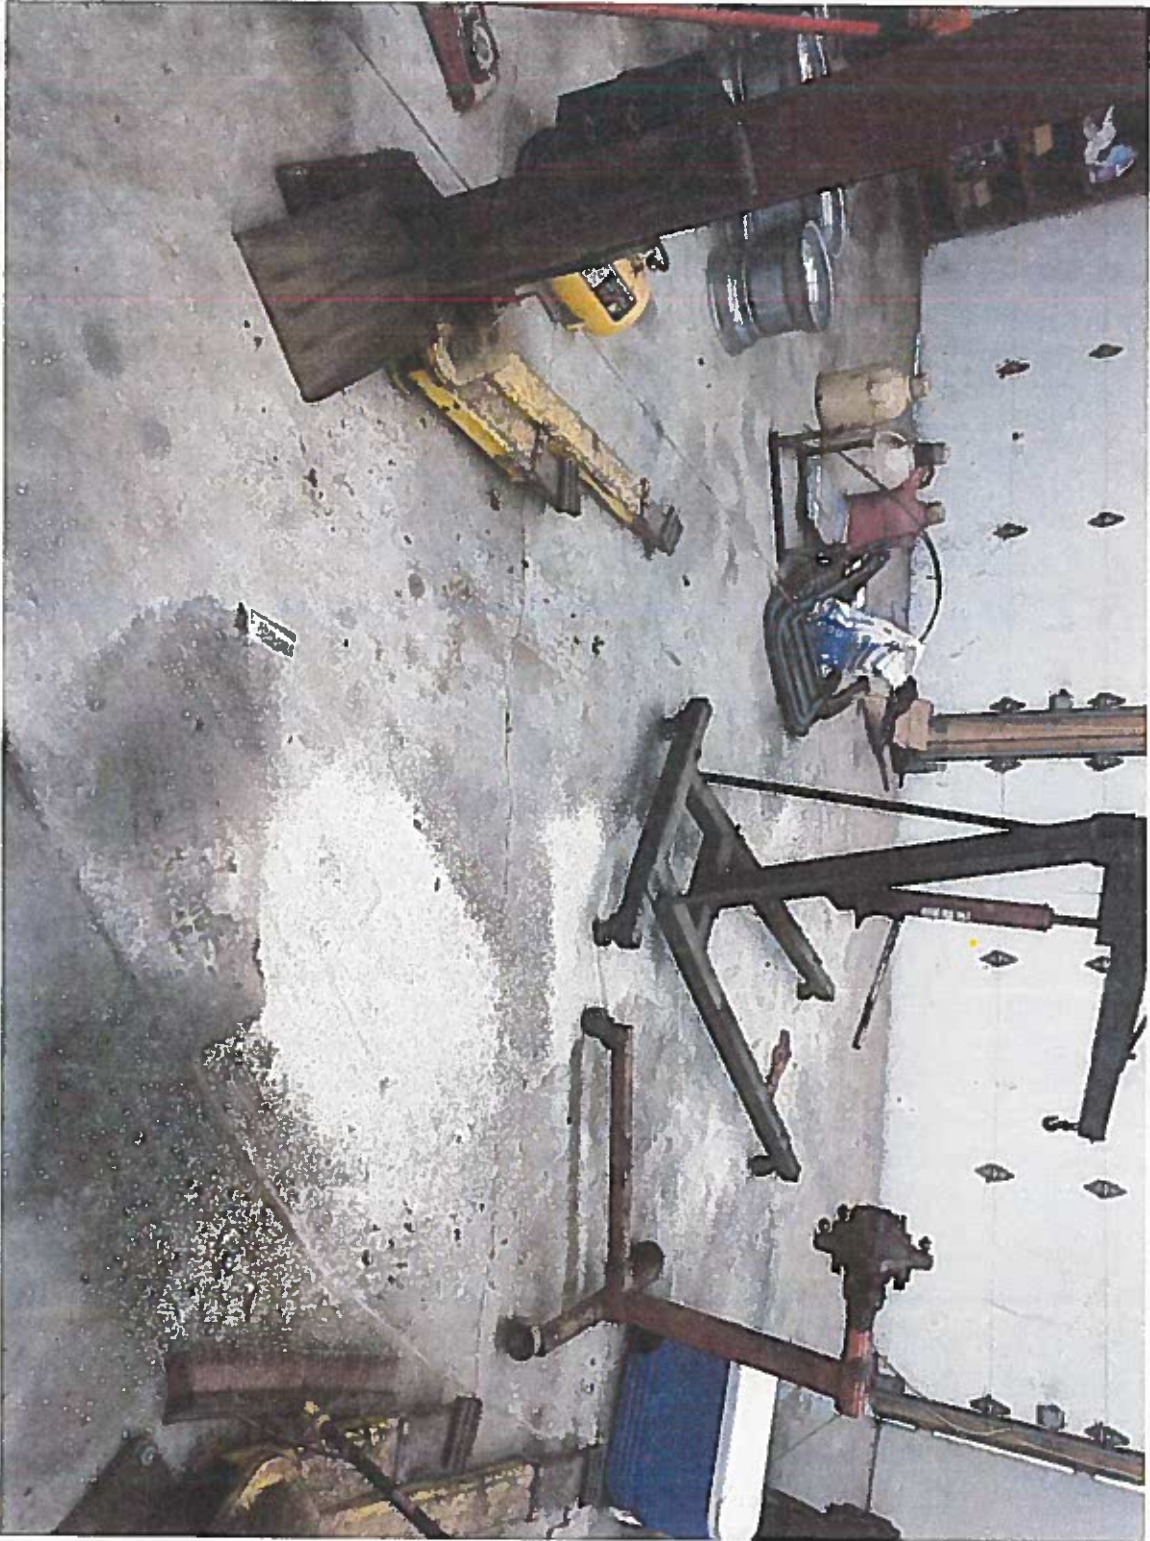
Oil spill absorbing material left on the floor in the rear white building.

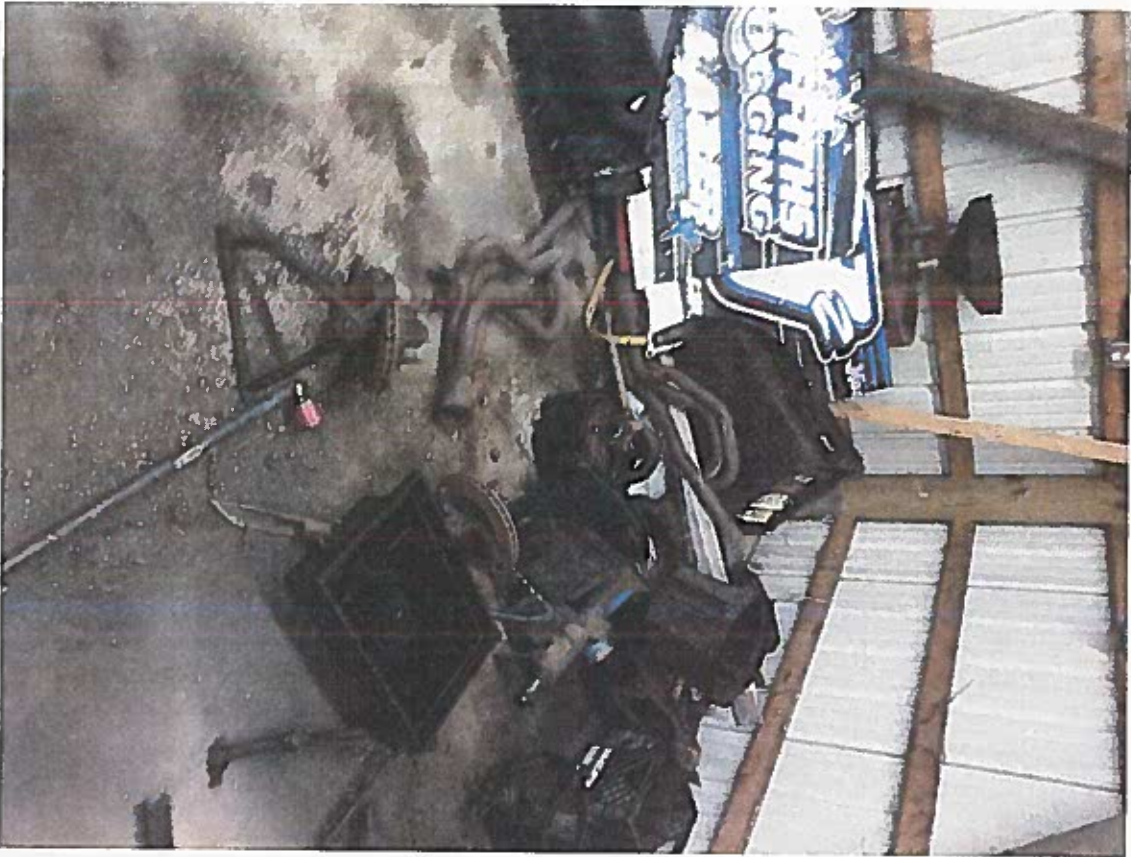
Open oil containers and oil spill absorbant material left on the floor.

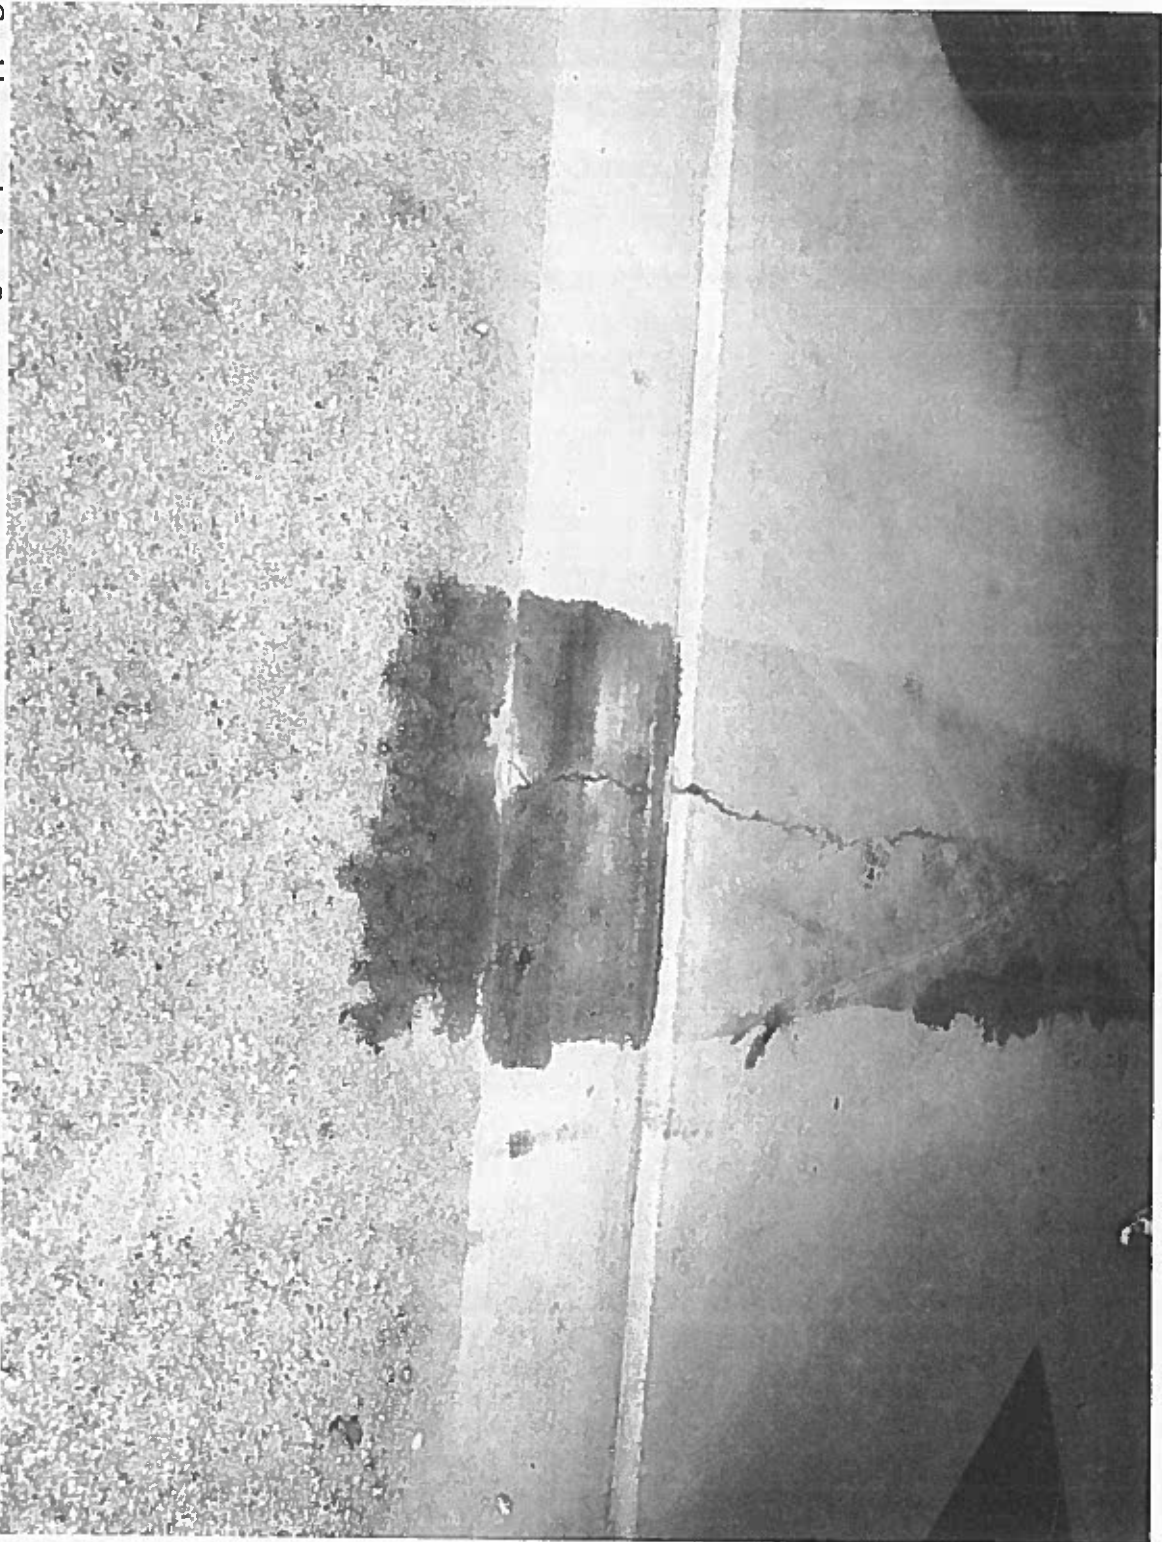
Cracking seen in shop floor area.

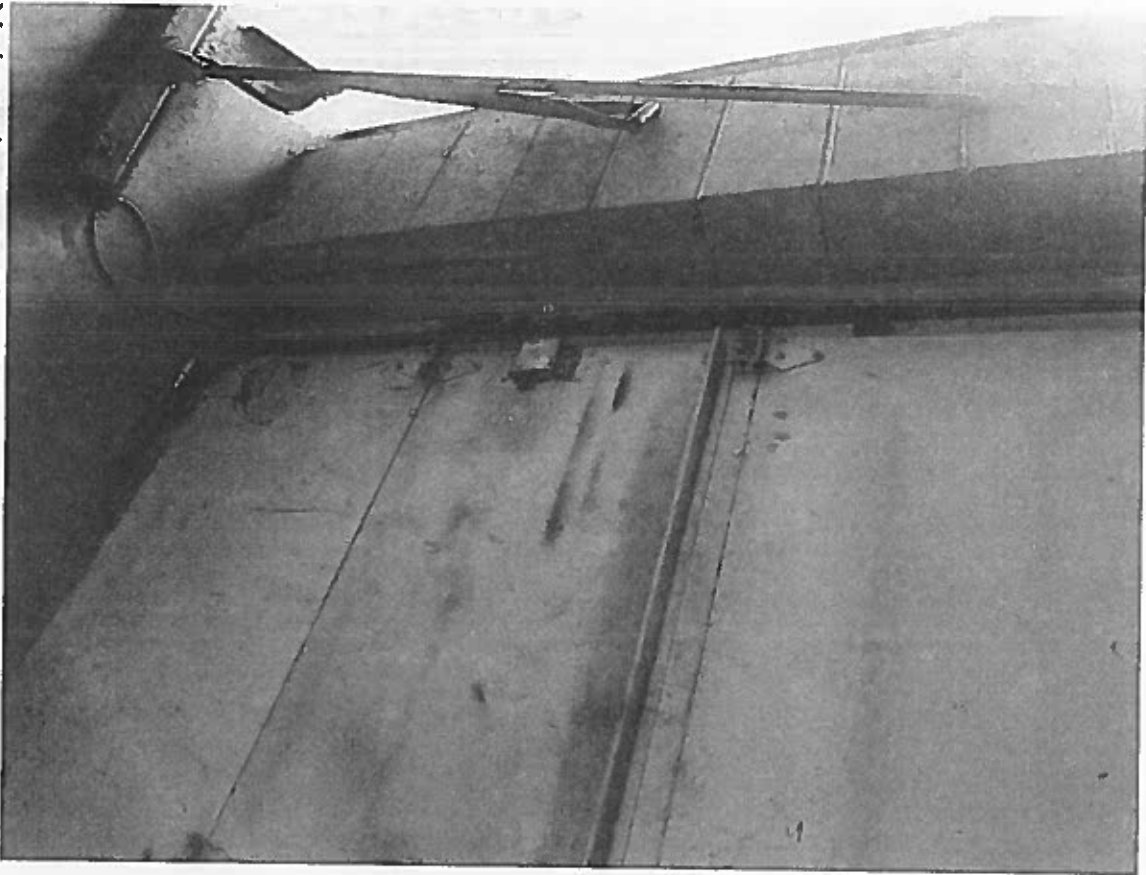
Moderate damage to this main bay garage door.

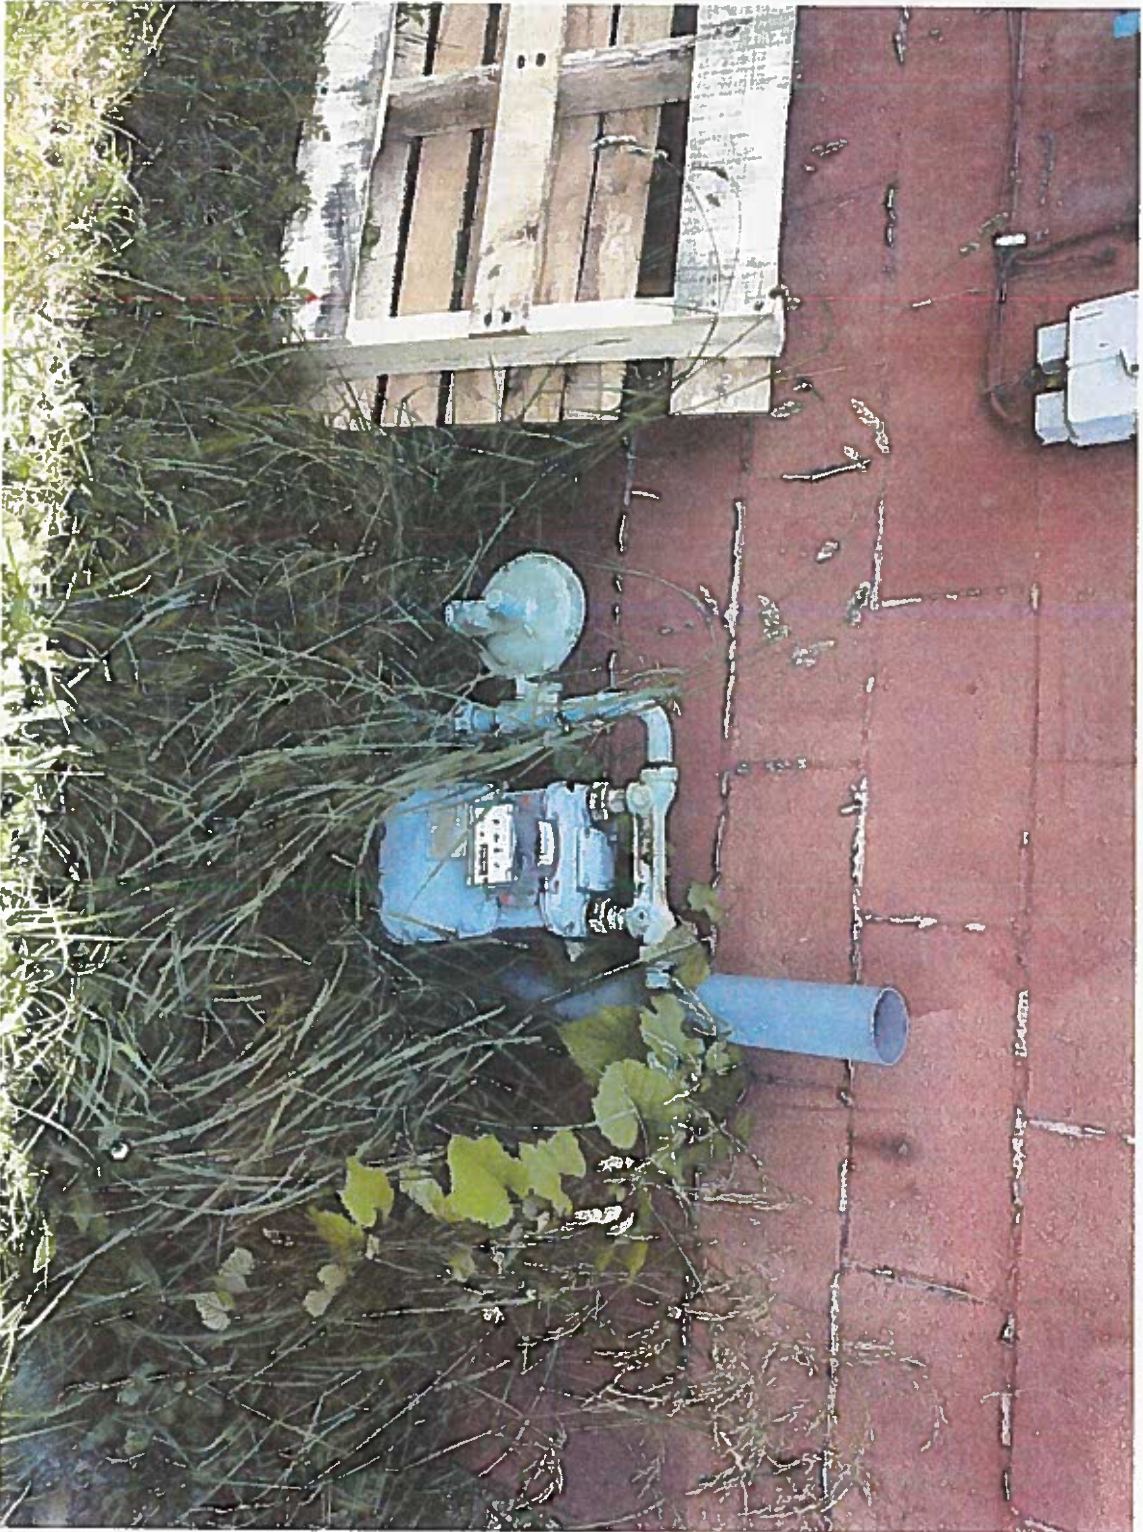
The plants near the property utility connections at the main front garage building needs trimmed.

Overgrowth and loose pallet near the property's utility connections.

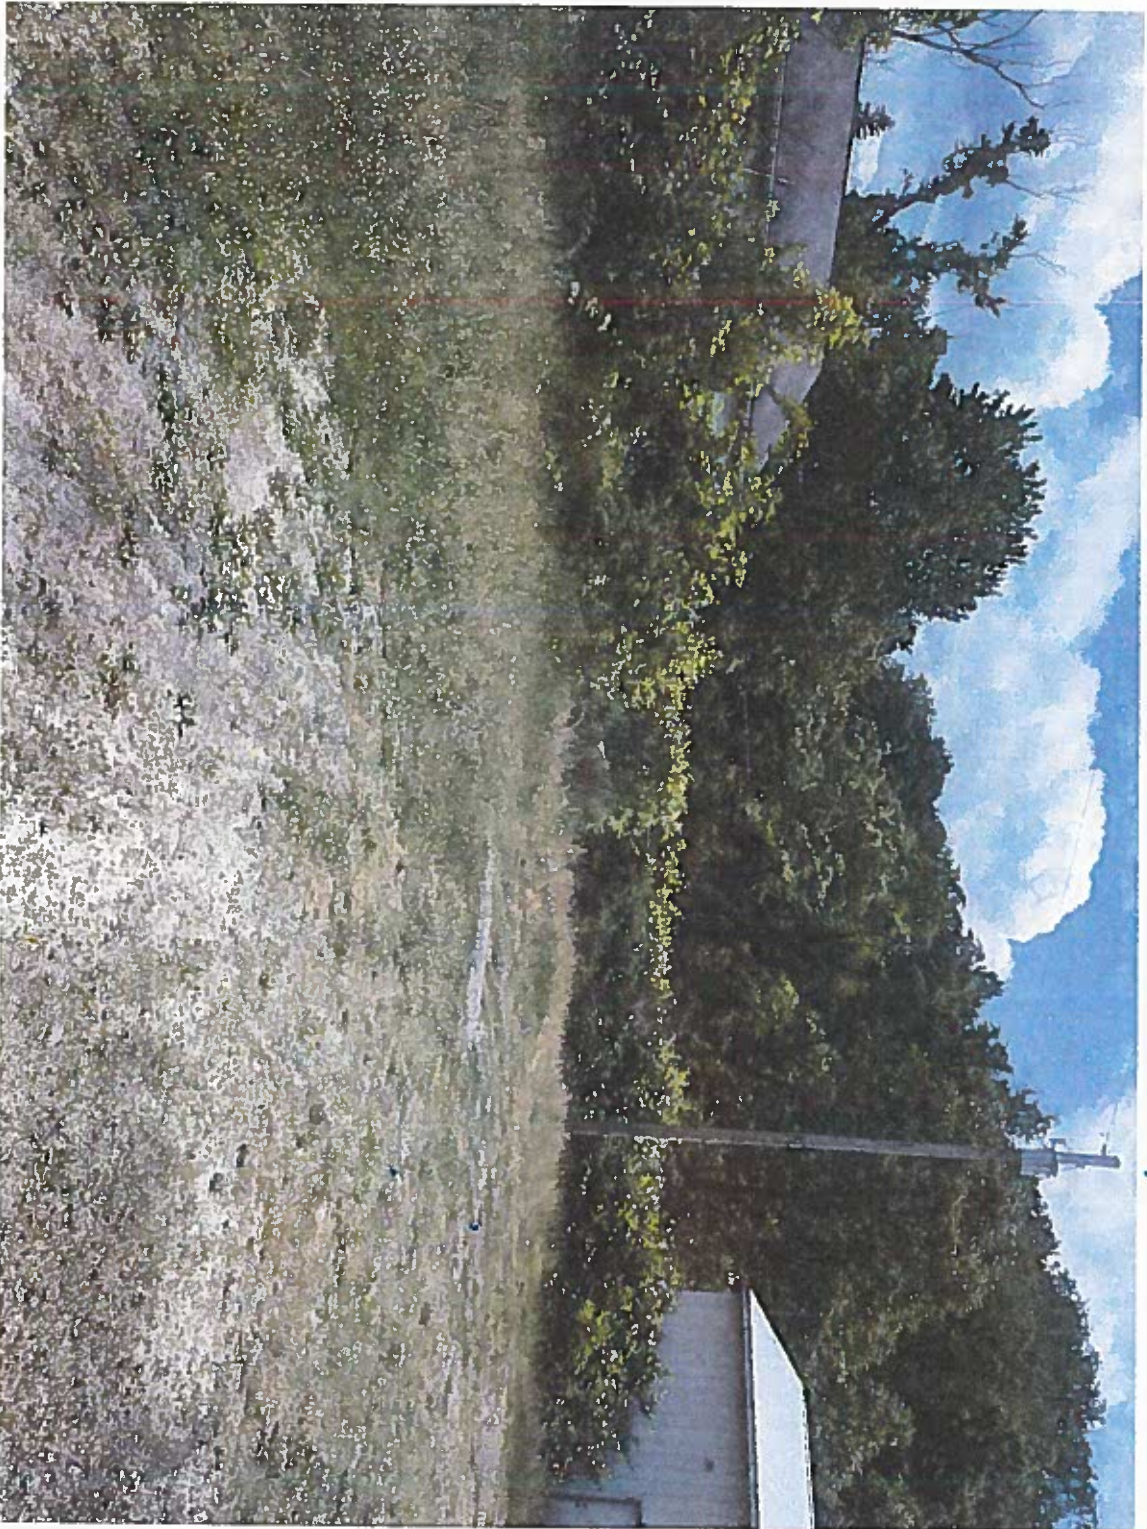
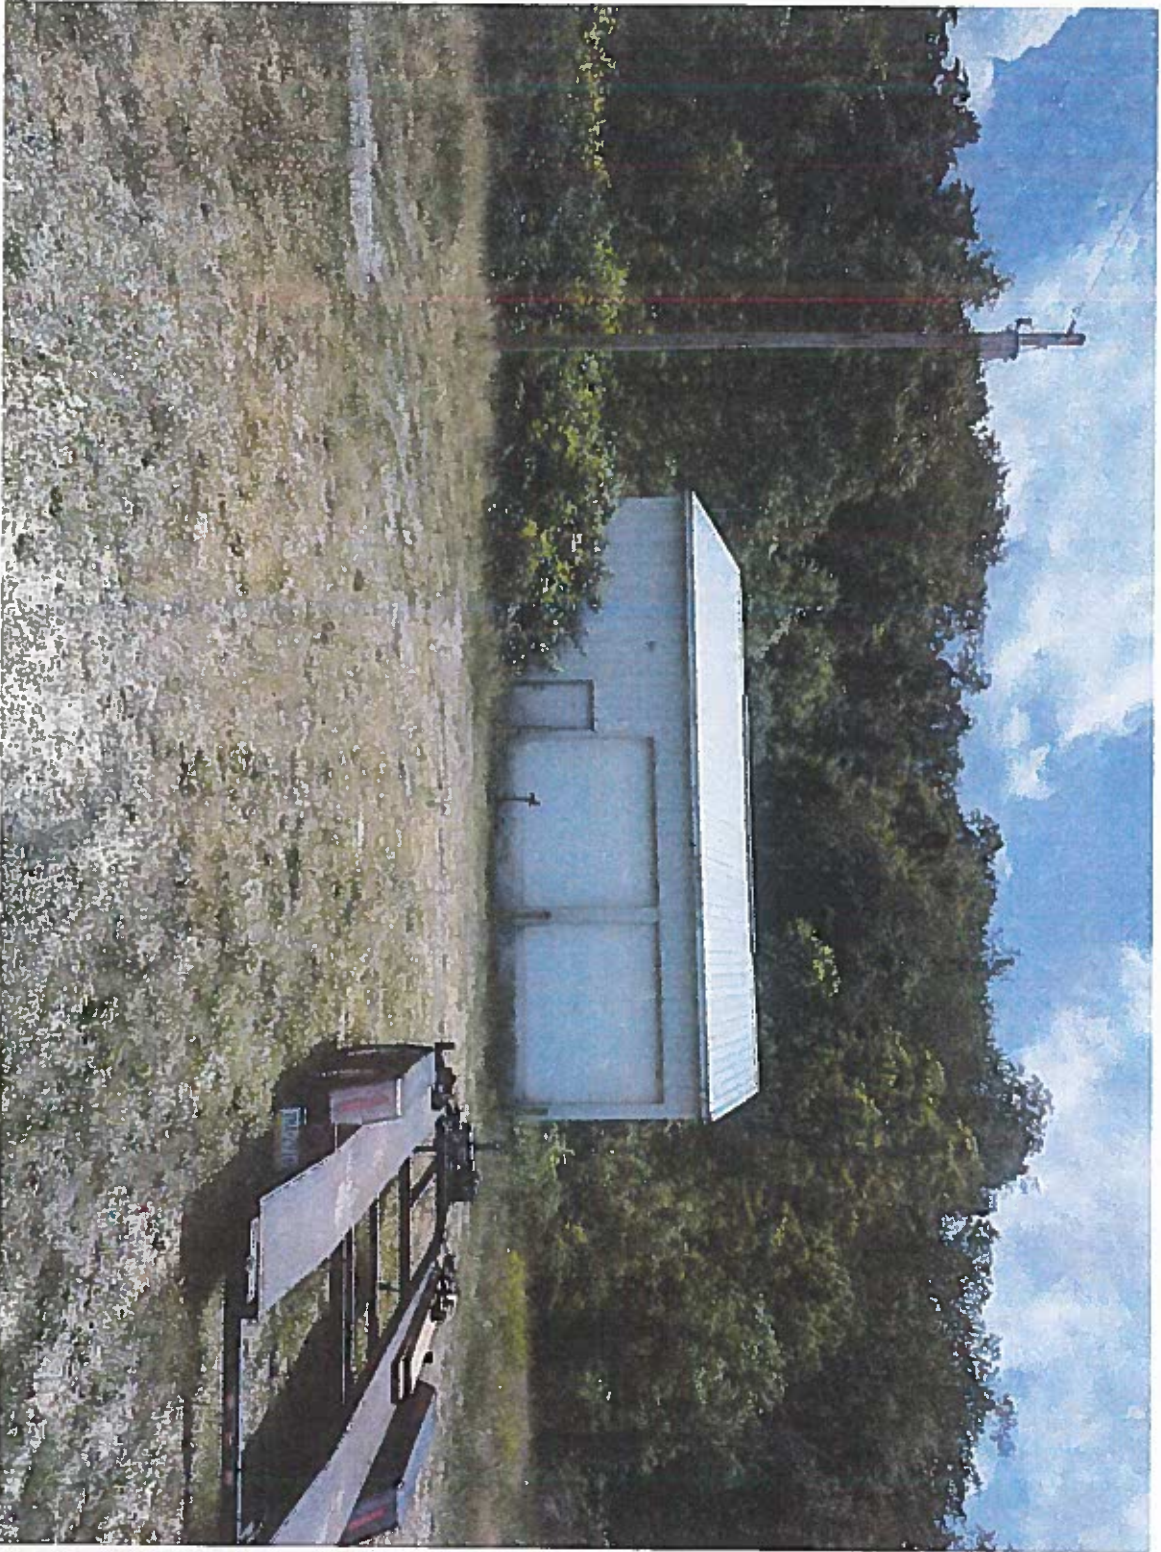
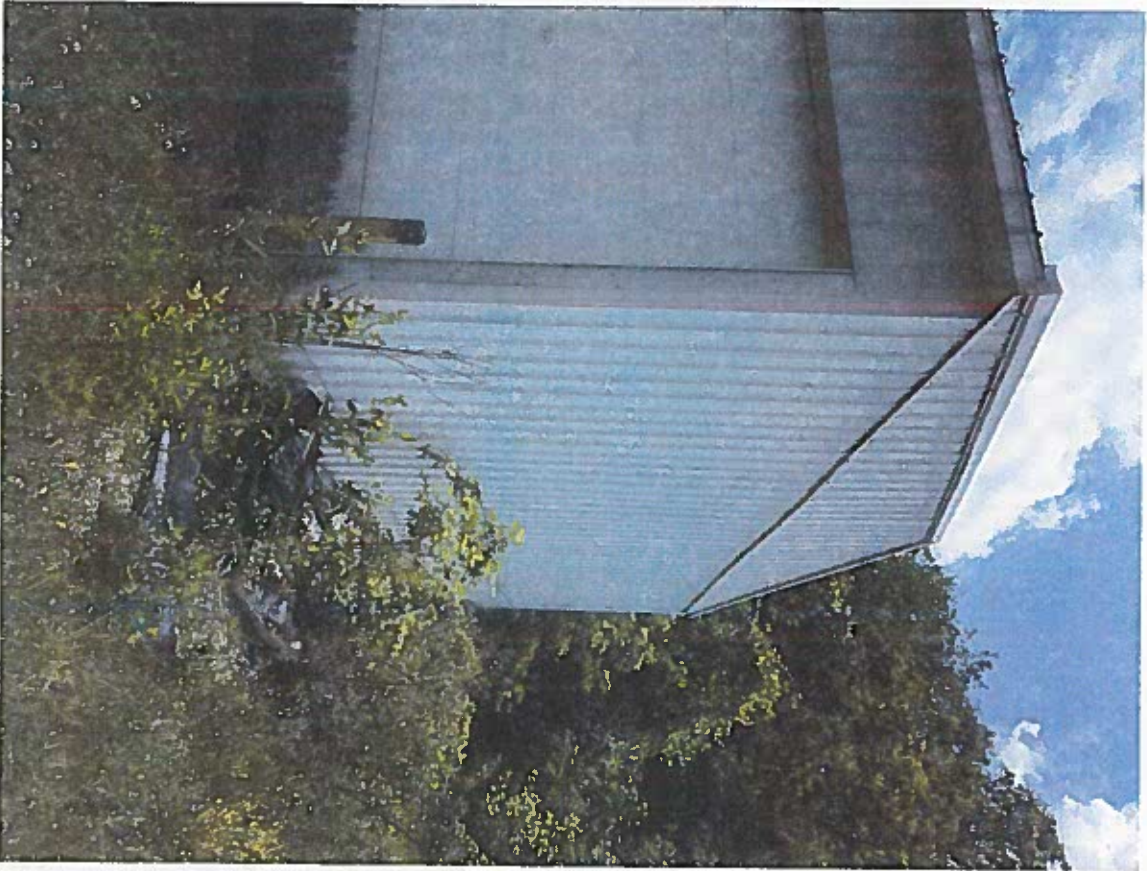
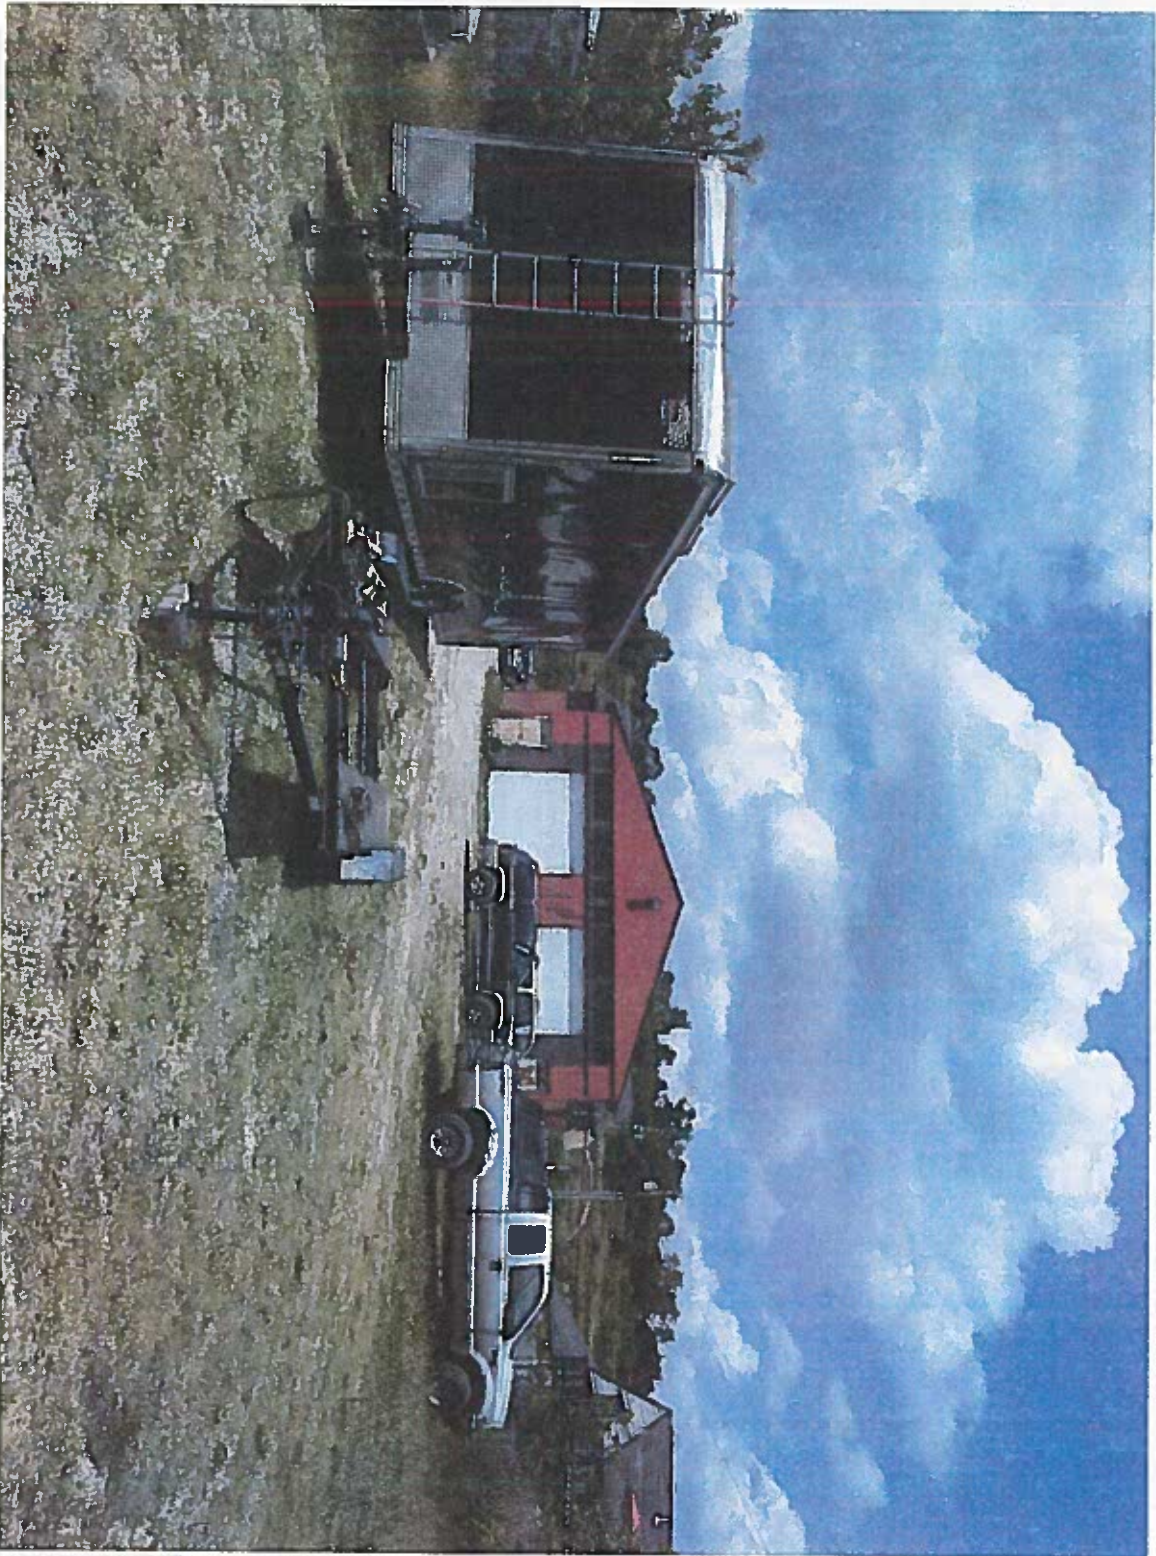
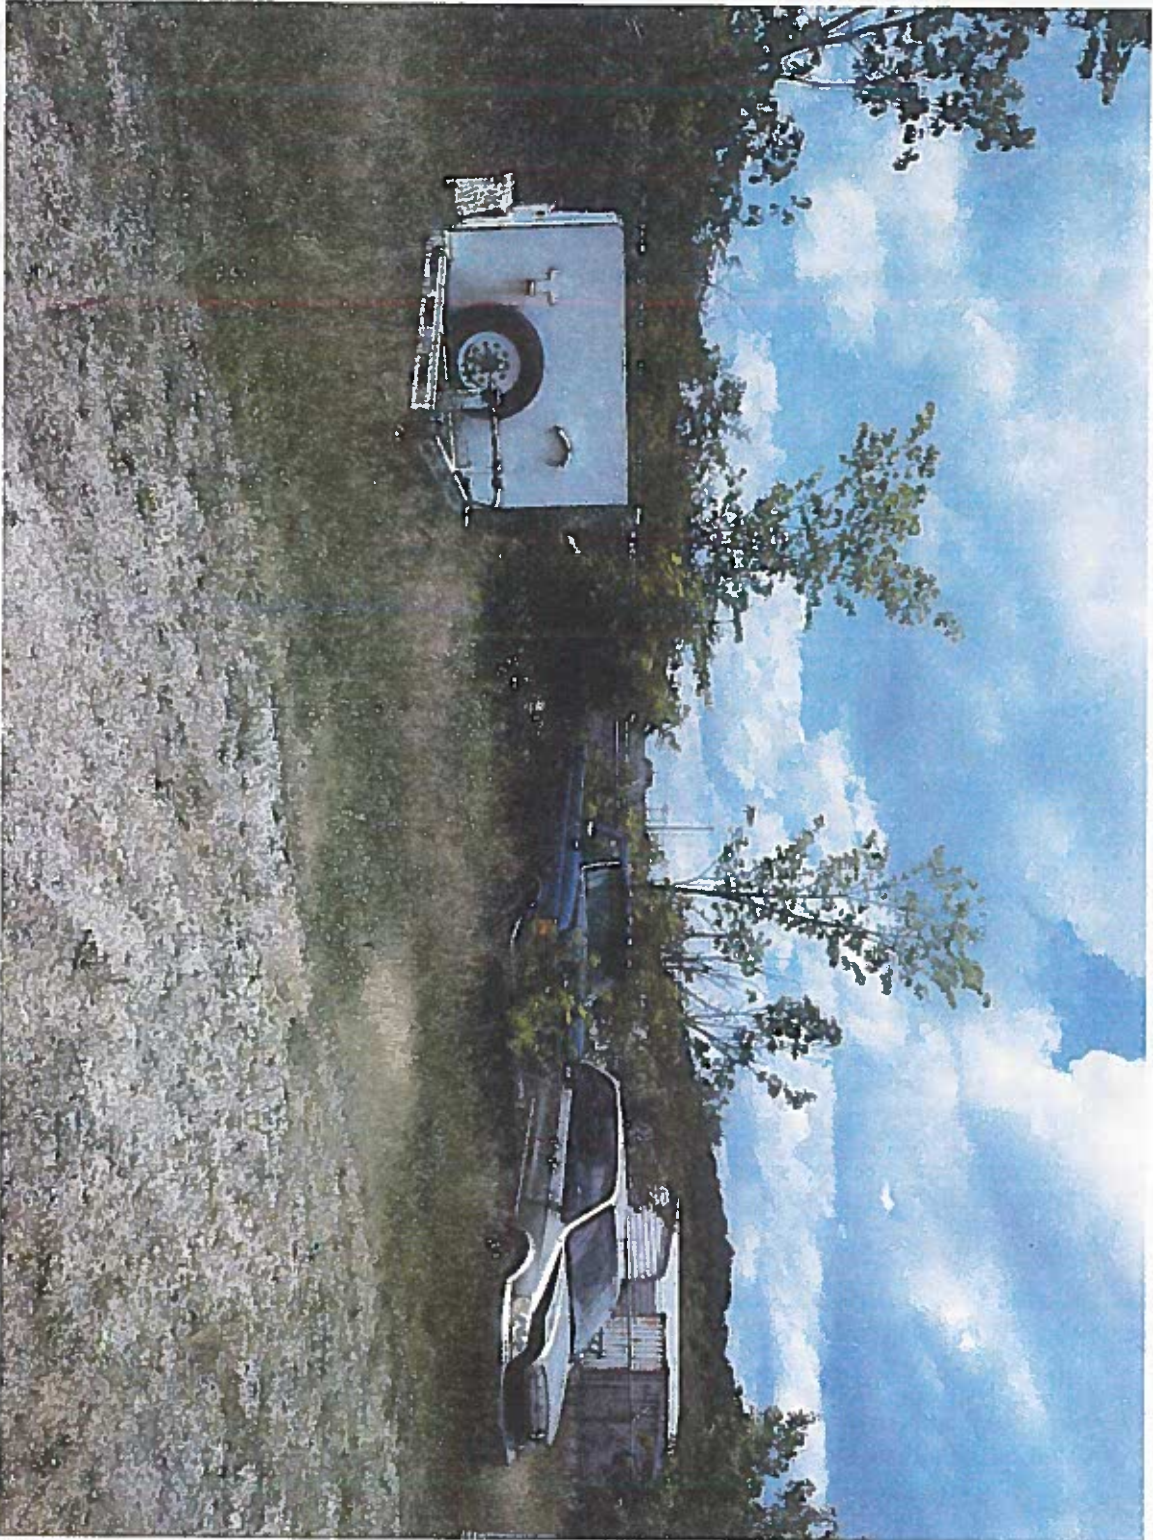
The rear storage lot has the largest quantity of plant overgrowth. At least one vehicle in the rear lot area was observed to have been parked so long that plants are growing through the vehicle. There are large plants growing adjacent to the rear white building.

Overgrowth and weeds on the rear lot.
